Report No.: LTR-SMPL-2003-0006

For: Transportation Development Centre and Aerodrome Safety Branch of
Transport Canada

Reference: Transport Canada Publication No. TP 13672E

RUNWAY SURFACE AND ENVIRONMENTAL CONDITIONS DURING FRICTION
TESTS AT K.I. SAWYER AIRBASE, MICHIGAN, USA – FEBRUARY 1999

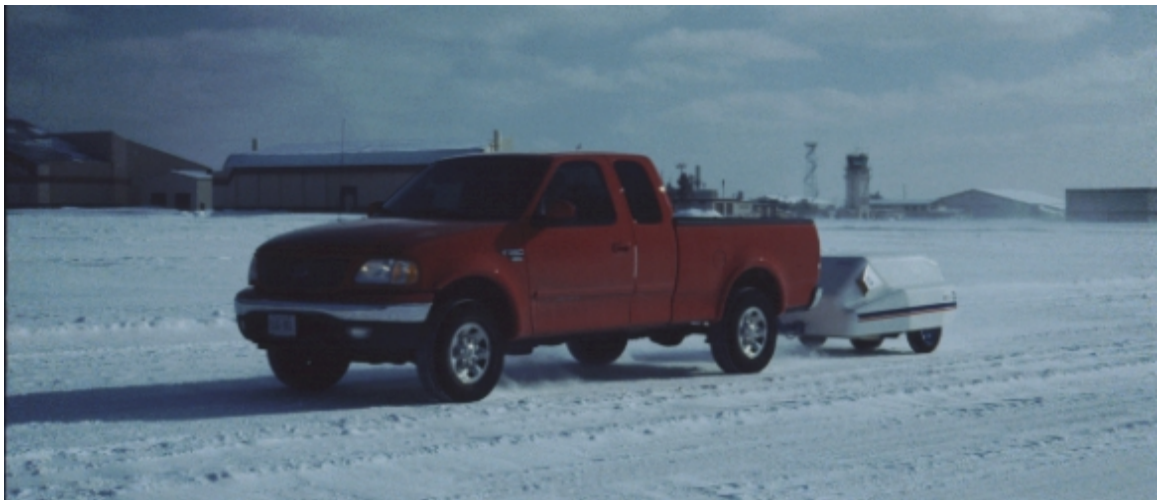
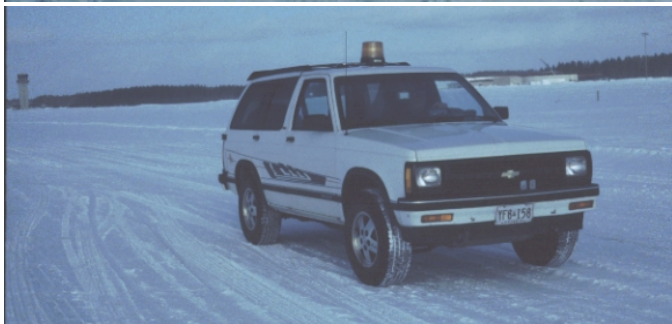
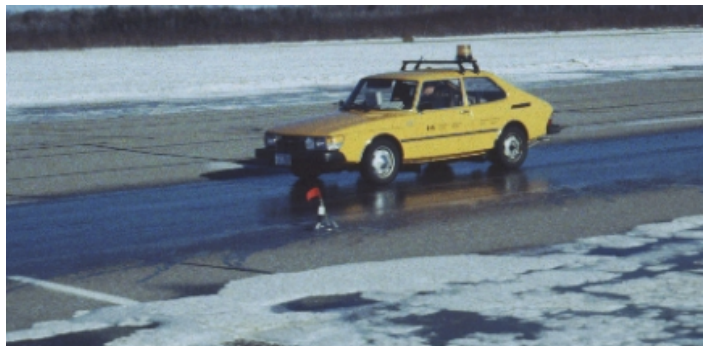
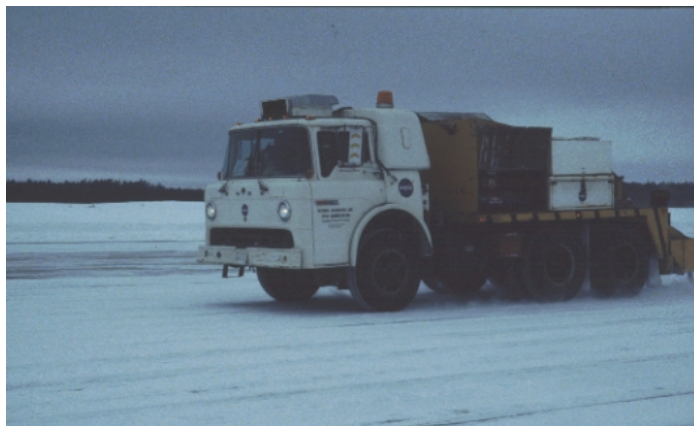
Figure 2. IMAG (a), ERD (b), SFT (c) and ITTV (d) used at K.I. Sawyer Airbase

The Transport Canada ERD mounted in a Chevrolet Blazer was used as one of the standard devices because of the correlation already established earlier with NRC's Falcon 20 aircraft. The ERD was used extensively at K.I. Sawyer Airbase in evaluating the conditions of the runway surfaces in the stopping distance in front of the designated test site for the aircraft as well as the two sides of the test bed. The B757 pilots used the ERD data for their decision-making processes.

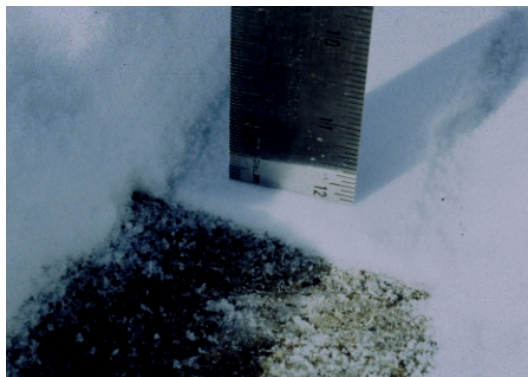
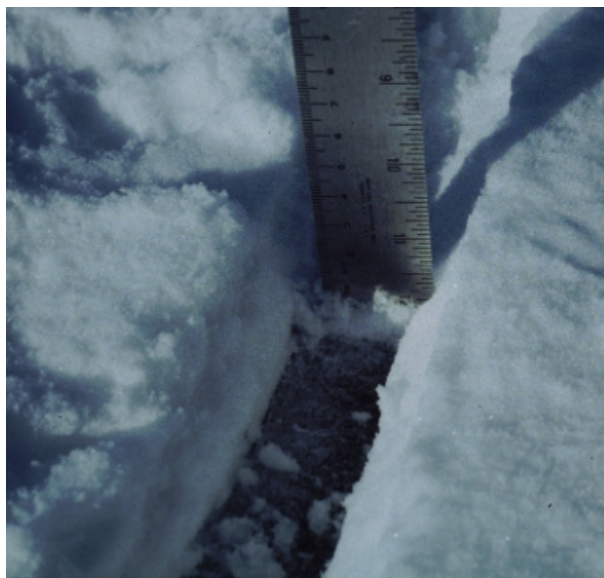
Figure 3. Tracks left on the snow by IMAG (a), SFT (b), and GT (c)

Snow stopped falling at about 13:30, the sky started to clear and the wind died. The sun came out at 14:45. At the request of the author, a series of special compaction tests were conducted on a 300 m long strip of undisturbed virgin snow on the section of taxiway A between D and E. The purpose of this test series was to determine the compaction of snow caused by test tires belonging to different test vehicles and/or devices. Since the snow was uniformly thick (45 mm) and moist, and because there was no wind, it was an opportune moment to conduct these tests. The snow was very moist, about 5% in moisture content, because tight snowballs could be made, but no water could be pressed out by hand squeezing. To prevent any spreading or splashing of snow by the tires of the operating vehicles and covering the tracks left by the test tires, the tests were performed at a constant speed of 40 km/h. To prevent overlapping tracks, only three devices were used. For ease of identification of the tracks, one device was run on one half of the lane. After the measurements were completed, another device was run on the other half of the track. The third vehicle was run along the central line of the track. These tests were performed from 15:00 to 15:30 using the IMAG, the SFT and a GT with slush cutter test tires (Figure 3). Fortunately, immediately after these tests, the B757 also traversed this area while taxiing on taxiway A on its way to the main runway. This provided an opportunity to measure the compaction activities generated by the aircraft (Figure 4).

Figures 3 and 4 show photographs of the tracks produced by the three ground vehicles and the aircraft during the compaction tests on the snow-covered taxiway.

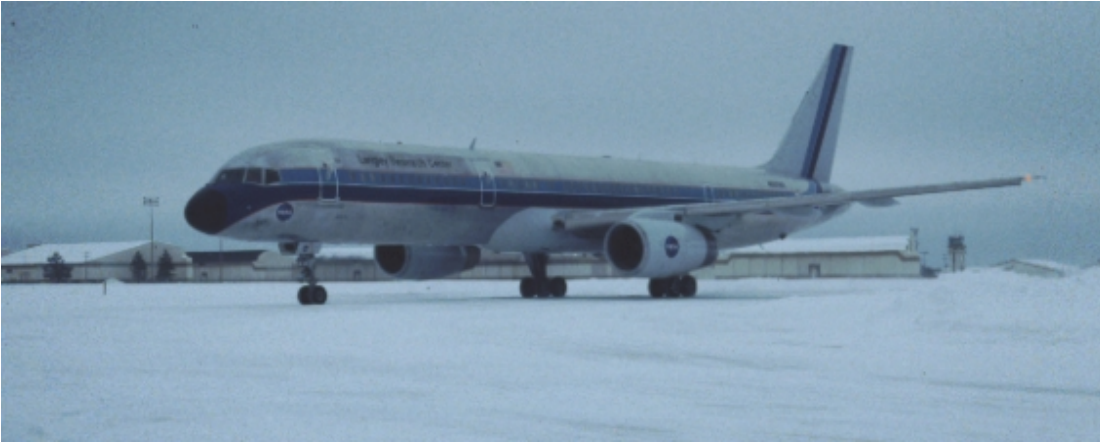
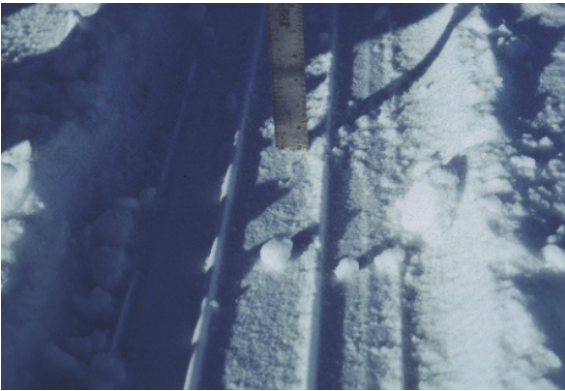
Figure 4. NASA B757 taxiing on the snowy parallel taxiway A at K.I. Sawyer Airbase, Michigan (a), track of compressed snow produced by one of the pair of tires of the left main gear (b), and the profile of compacted snow in the central section of the track (c)

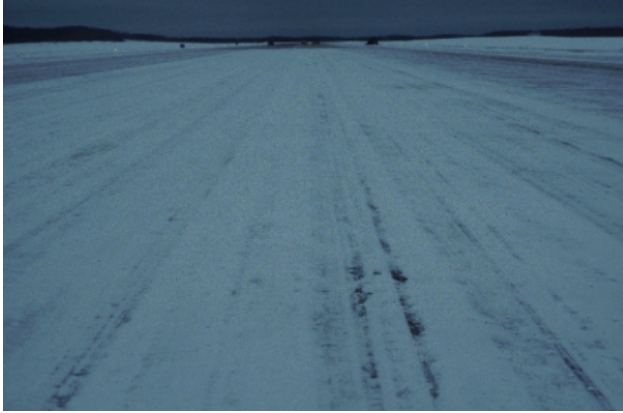
Figure 6. Tracks left by the aircraft and the ITTV on runway 01-19 during the aircraft tests and the ground vehicle tests after 12:15 on Sunday 7 February 1999 (a). At 65 km/h, ITTV made a pattern of broken ice pellets in the mid section under the tire (b and c). Snow temperature was -4.4°C

Following the completion of the ground vehicle tests, the snow strip was examined visually. A general view of the strip at this time can be seen in Figure 6a. It was impossible to identify the tracks left behind by the aircraft tires in conjunction with their flight numbers. The track left behind by the ITTV test tire could be identified. It was of some interest, as can be seen in Figures 6b and c. In this case, the tire cracked the compacted snow and produced a pattern of ice pellets.
